The Light Atco

However, particularly due to their age (over sixty-years old) the following problems arise on machines not reconditioned by us:

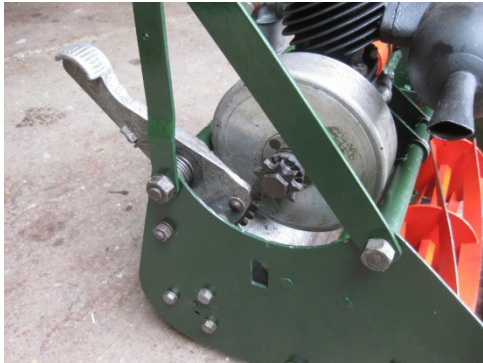
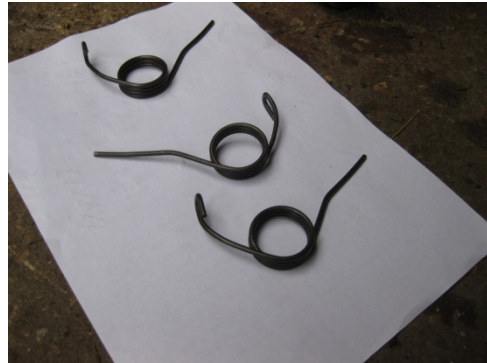
The Kick-start mechanism is prone to wear on the Light Atco- a key assembly. We fit unworn and perfectly operating assemblies (including new return springs) to our mowers

The condition of the pedal, sprocket/ratchet and spring is key to smooth operation

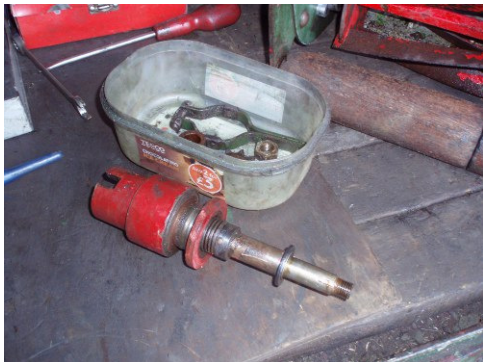
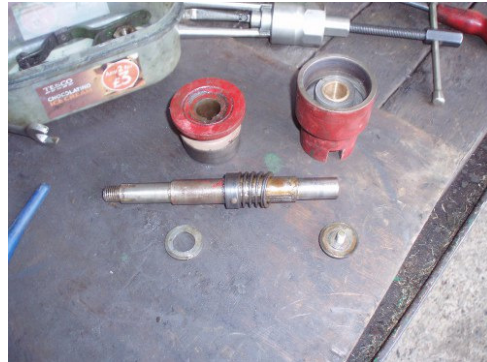
The clutch can operate erratically, if it is worn; as is often the case. We rebuild the mower's cone clutch assembly, including fitting new bushes and shims

Photos showing the Light-Atco's clutch stripped down and ready to be overhauled

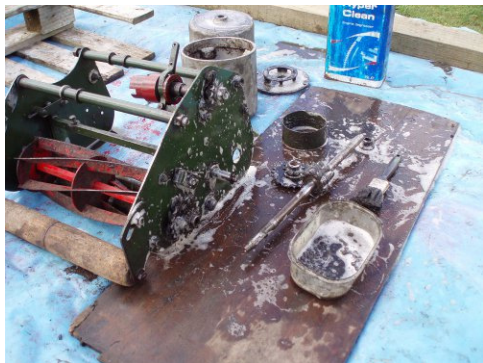
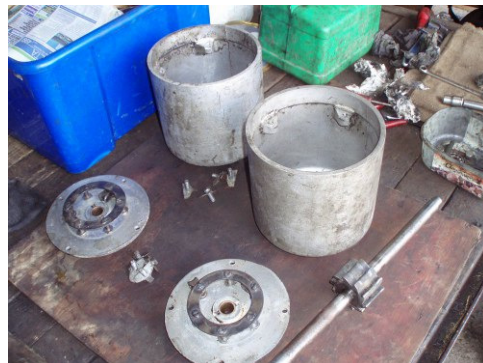
Due to its age, the majority of bushes & bearings on these mowers show extensive wear and need replacing

Light Atco being cleaned so that assemblies, such as the rear-rollers (right), can be overhauled, with new bearings and bushes fitted

We fit new ball-races and bushes to the mower's assemblies, as standard

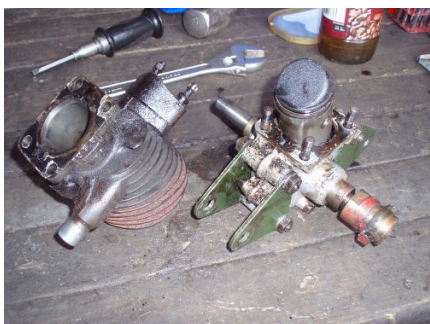
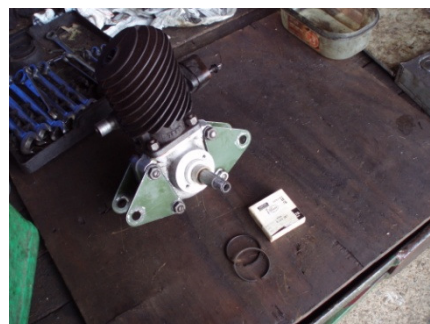
The two-stroke Villiers engine's bearings and bore can wear (often due to inadequate mixes of two stroke oil)- this leads to bad and underpowered running

The Villiers engine is decarbonised and reassembled with new piston rings

We rebuild the engine, restoring its compression and ensuring that it operates to the highest standard

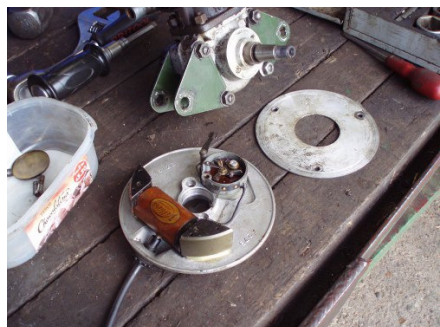
The ignition becomes unreliable and starts to fail (ie. does not produce a spark)

The ignition (shown above on its backplate) is thoroughly overhauled with components tested and new parts fitted to ensure reliability

We fit tested ignitions making sure that they are in prime condition and replacing key components such as coil and condenser (still obtainable new, through our suppliers)

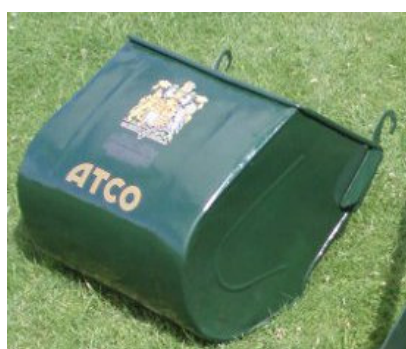
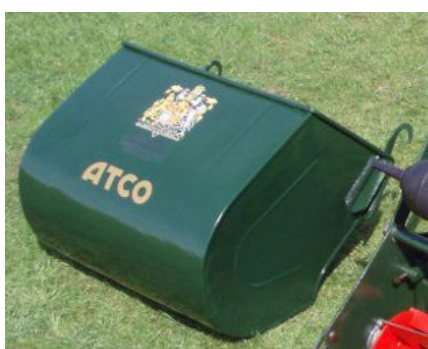
The aluminium grassbox, due to its position at the front of the mower, is prone to denting and damage

Two examples of the restored grassboxes we supply with our Light Atcos

From our healthy selection of grassboxes, we select the best shaped and structurally sound examples (repairing and meticulously filling them, where appropriate)
