## The Webb AB-Series (14" AB1474, 18" AB1476 & 21" AB1478)

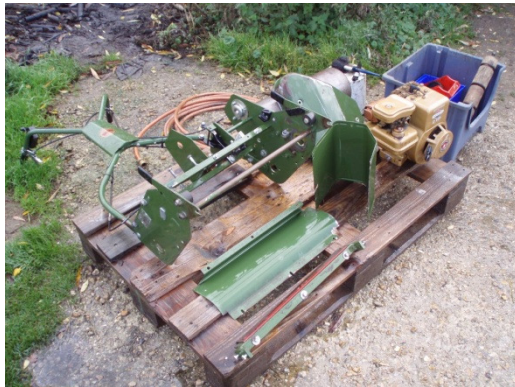
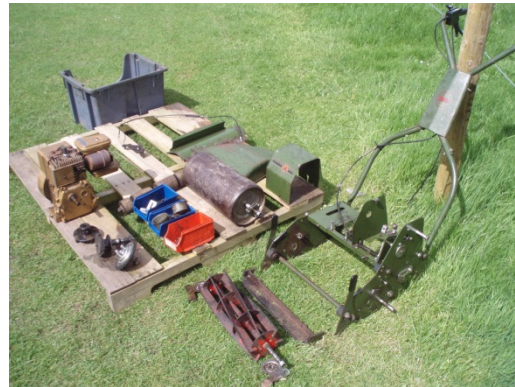
Key bearings suffer from lack of lubrication and maintenance

Like most mowers of its era, the Webb AB-series must be completely stripped down to access and lubricate all of its bearings effectively

We strip down the mower cleaning, re-lubricating every bearing; as they can only be accessed in this way. Key bearings in the transmission are replaced

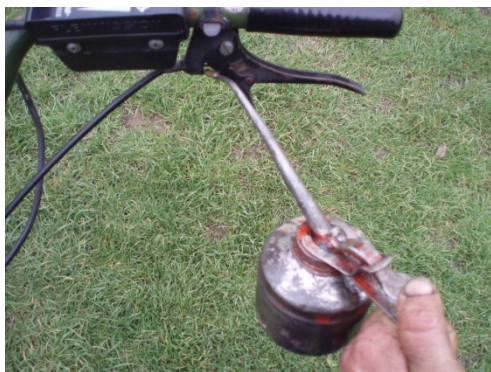
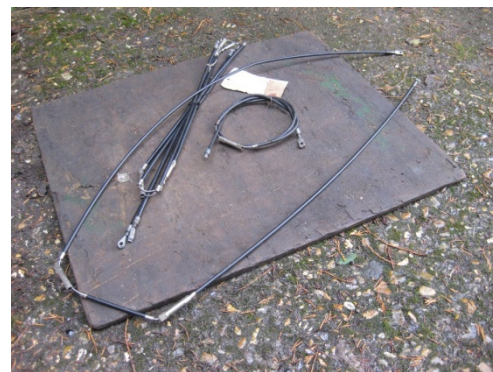
Clutch cables stretch and break from lack of lubrication

Drive cables must be kept in good condition with regular lubrication. We hold plenty of replacement stock for our mowers(right-hand photo showing new cables)

No cables we fit are stretched, meaning that they have plenty of adjustment left- neither are they frayed or distorted. We maintain a supply of new cables for our rebuilt machines

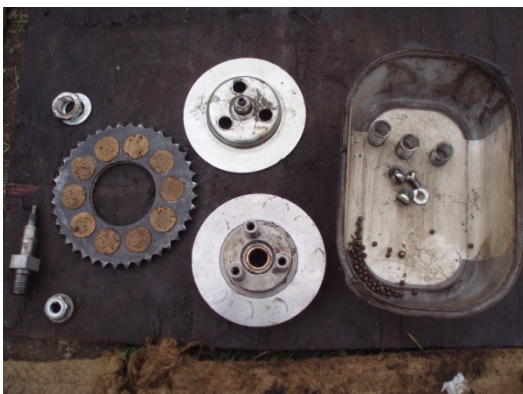
The cork material in the rear-roller clutch compresses and wears leading to slippage  
We can fit new high-density cork inserts to recondition the clutch

A rear-roller clutch stripped down awaiting cleaning, replacement parts (including cork inserts, pictured below) and lubrication

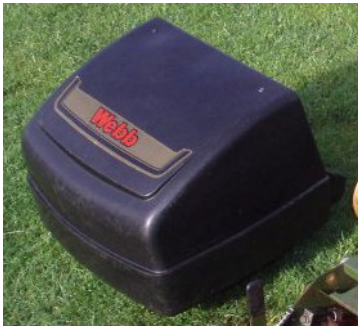
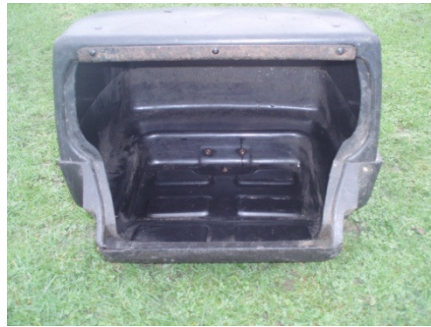
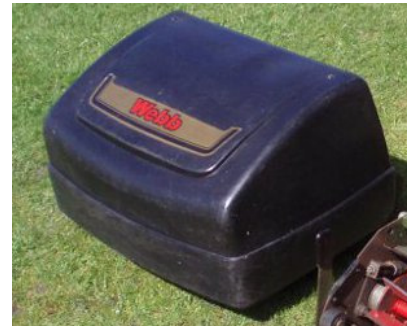
The strong plastic grassbox can be damaged by misuse  
Although an advantage over metal grassboxes (which dent and rust) when damage has occurred to a mower's grassbox, we have a large selection of spares to replace it

Examples of good undamaged grassboxes we supply with our mowers

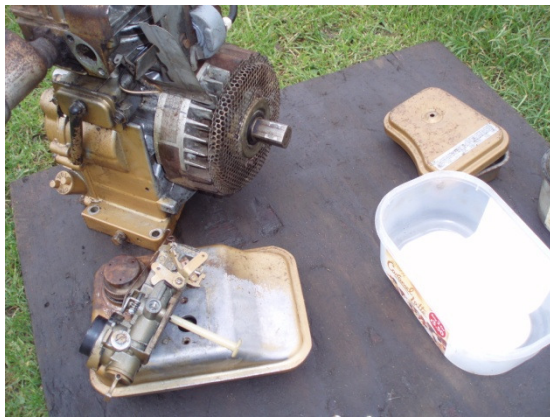
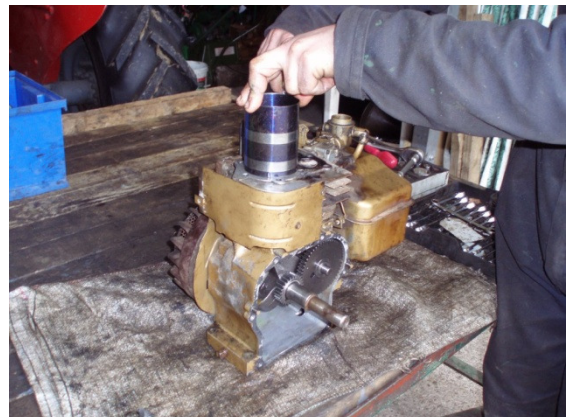
The Briggs & Stratton engine (like all engines) can wear with age  
We are able to obtain every key component for the Briggs & Stratton engine, new, which means that our mower's engines are reconditioned

We rebuild the Briggs & Stratton engines' carburettors and recondition them internally by replacing pistons and re-seating valves

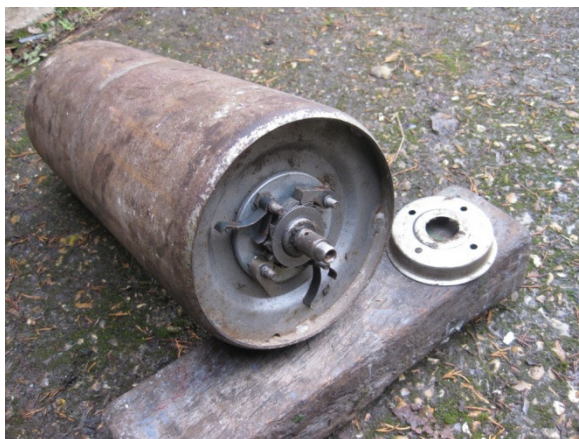
The condition of the split rear-rollers (18" & 21" models) and the differential can deteriorate through careless use and lack of lubrication  
We strip-down and replace any component in the assembly that is worn (including the rollers themselves)

The rear-roller mechanism is stripped down, lubricated and reassembled with new components (such as bushes and springs)
