## The Ransomes Auto-Certes

Excellent designed and with the hallmark build quality of all Ransomes, the Auto-Certes became the standard machine for preparing fine-turf areas, such as cricket pitches, over decades.

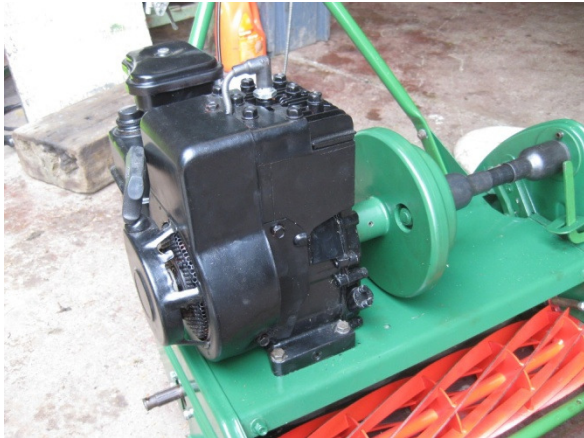
Badly running engines (or replacement engines that run too fast) do not engage/disengage the centrifugal clutch correctly.

The Auto-Certes Mark 3M's original Briggs & Stratton engine- reconditioned to align with and operate the mower's clutch correctly

We recondition the original engine for smooth running and operation of the clutch

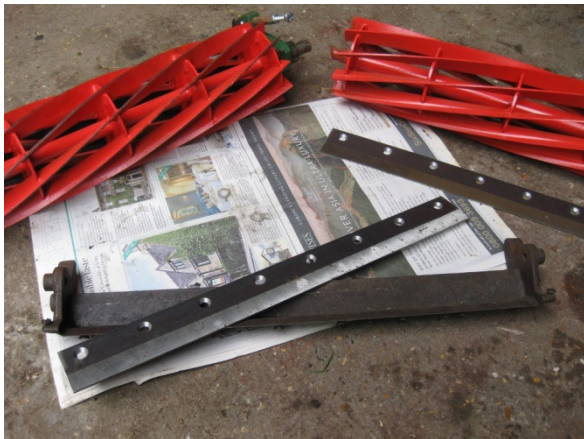
The condition of the cutting cylinder and bottom blade is key to the quality of cut  
We only use cutting cylinders which sharpen nicely with the new shaver bottom blades that we fit

Our reconditioned Auto-Certes have new shaver blades fitted to complement our specially selected cutting cylinder assemblies

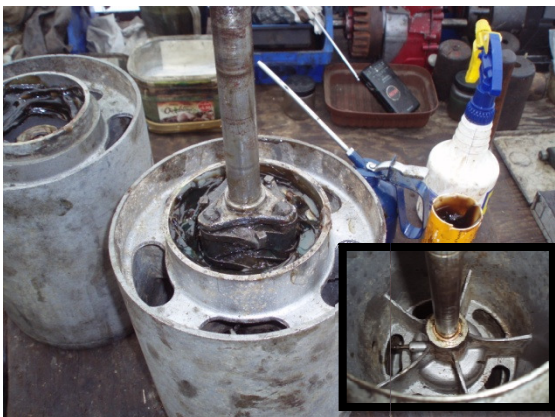
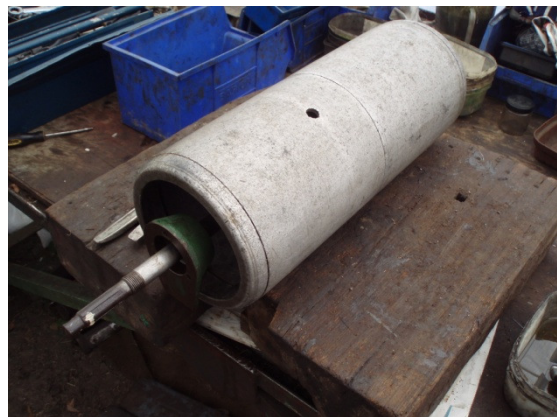
The aluminium rear-rollers run on bushes, which are generally worn, due to a lack of lubrication We fit new rear-roller bushes and supply good unworn rollers and spindles

Auto-Certes Rear-Roller Differential lubricated- reconditioned and reassembled

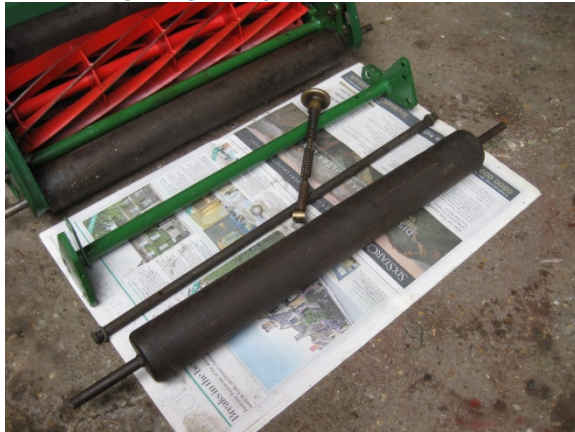
The front roller has sealed bearings, which wear and sometimes even seize/collapse- damaging the roller's carriage assembly and affecting the evenness of the cut.

*Our front roller assemblies are fully stripped down and rebuilt with new components*

We change front roller bearings, as standard, and replace any worn components relating to the cutting height adjustment

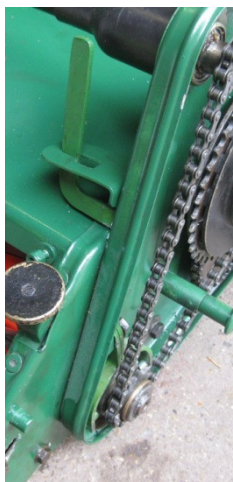
The Auto-Certes has a disengagement mechanism combined with its cutting cylinder sprocket, which is crucial to its operation- a worn mechanism will not disengage and will eventually prevent the cutting cylinder revolving (due to wear)

*The components in the cutting cylinder disengagement mechanism (the mechanism allows the mower to be transported without the cutting cylinder revolving)*

We fit new and unworn components relating to the cutting cylinder disengagement, which will last for many decades with basic maintenance

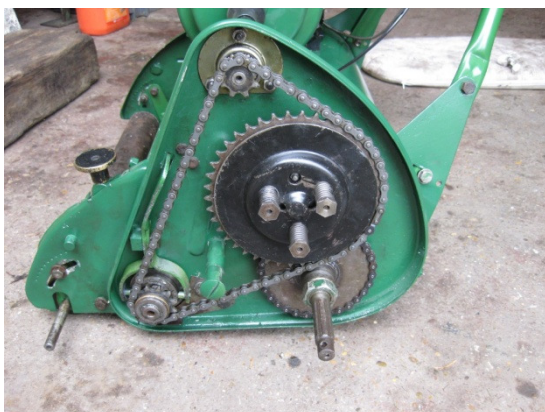
Chains are not tensioned which leads to worn and broken sprockets

Failure to replace/tension chains leads to wear in the mowers' sprockets and eventually irreparable damage

*The Auto-Certes chain assembly is strong and well made but needs to be adjusted regularly and/or replaced when the chains reach a certain level of wear*

We regularly fit new chains to Auto-Certes, as well as correctly tensioning existing chains.
