The Ransomes Matador

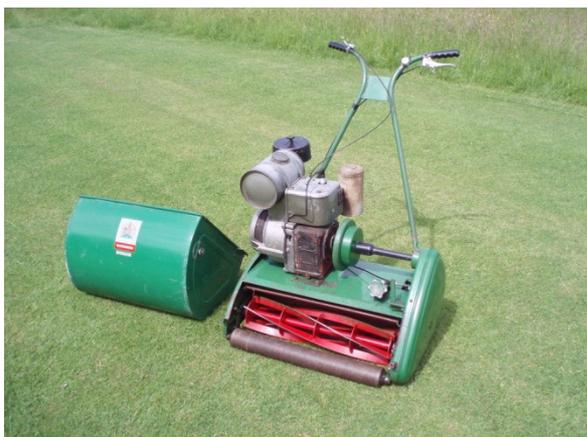
Badly running engines do not engage/disengage the centrifugal clutch correctly. We recondition the original engine (MAG) for smooth running and operation of the clutch and fit replacement components (including clutch shoes) to the assembly

A reconditioned Ransomes Matador with its MAG 1026 engine having been rebuilt

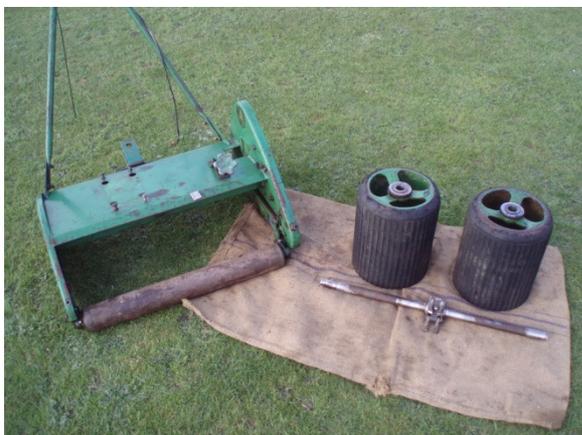
The split rear-rollers stick (due to lack of lubrication) greatly reducing the mower's manoeuvrability

The rear-roller assembly removed from a Matador awaiting lubrication of the differential and reassembly

We completely strip down, clean and lubricate the rear-roller mechanism

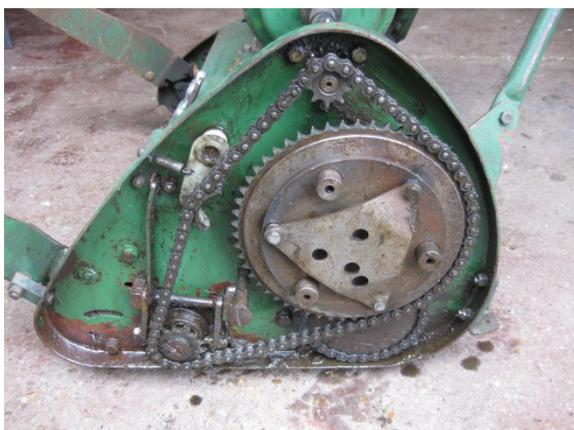
Chains are not tensioned which leads to worn and broken sprockets

The Ransomes Matador chain assembly is strong and well made but needs to be adjusted regularly and/or replaced when they reach a certain level of wear

We regularly fit new chains to Matadors (along with new chain tensioners), as well as correctly tensioning existing chains. Failure to replace/tension chains leads to wear in the mowers' sprockets and irreparable damage

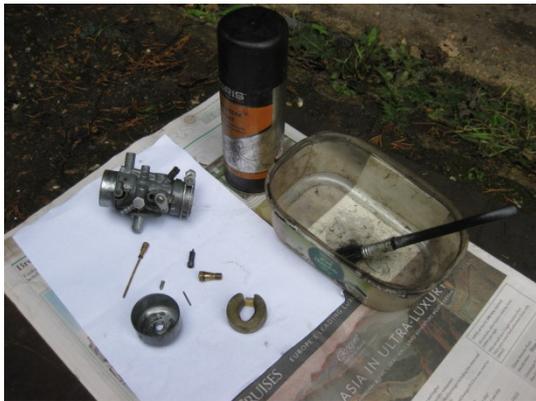
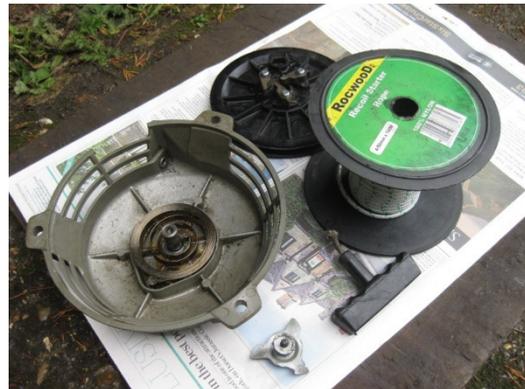
The carburettor is prone to leaking fuel, as is the fuel tap (due to age)

Pull-start assemblies can stop meshing, due to wear, so they do not operate properly
Our pull-start assemblies are thoroughly overhauled with new components fitted to ensure reliable operation

The MAG engine's carburettor and pull-start stripped down to be overhauled

We thoroughly overhaul and test our carburettors, fitting new components where appropriate. Fuel taps are checked over and generally replaced
